Manhole Inspection Summary

Manhole # S21G__055MH

Location Address: **1936 FAIRMOUNT-BALTIMORE** Cross Street: **PAYSON-MONROE**

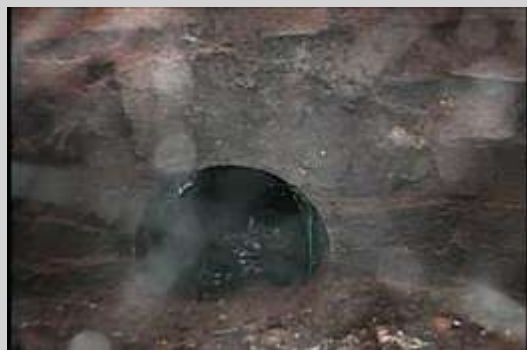
12 O'Clock Outflow

8 in. Circular Gravity Sewer
Pipe Out @ 12 O'Clock

Deposits: ☐ None ☐ Mud ☐ Sludge ☒ **Debris** ☐ Grease

Silt Depth: **1** (in.) Deposits Extent: **Light**

Infiltration: **None** Pipe Seal Cond: **Sound**
